**REPORT ON
PROPERTY CONDITION ASSESSMENT AND
CAPITAL NEEDS PLAN
WOLF TRAP WOODS HOME ASSOCIATION
VIENNA, VIRGINIA**

**Project No. 16076-001
13 April 2017**

Subject: Report on Property Condition Assessment and Capital Needs Plan
Wolf Trap Woods Home Association
Vienna, VA 22182

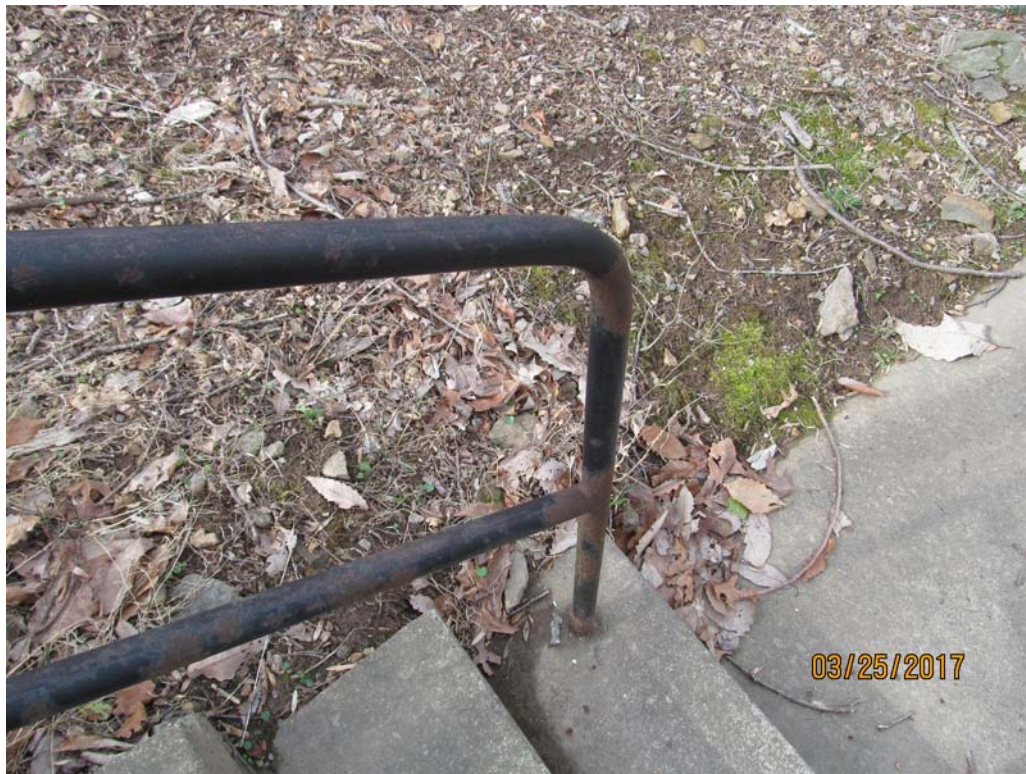
Painted metal pipe railings were observed along the sides of concrete steps located between Cricklewood Court and Trap Road. The railings were noted in overall fair condition; with corrosion noted at railing joints and bases. The site contacts reported that repairs to rusted and unsafe railings were performed in October 2012. In general, metal railings can be expected to provide approximately 40 to 50 years of useful life. Pons & Associates recommends the step railings be replaced in Year 12 of the Term. Repairs and painting to the railings are considered to be minor maintenance. A wood and concrete crib retaining wall approximately four feet in height was noted proximate to a section of the southwestern boundary of the property. The retaining wall appeared to be in fair condition with no deficiencies noted. The walls and railings can be expected to last through the Term with repairs and painting considered to be minor maintenance.

Photograph No. 5: Typical corrosion at step railings.

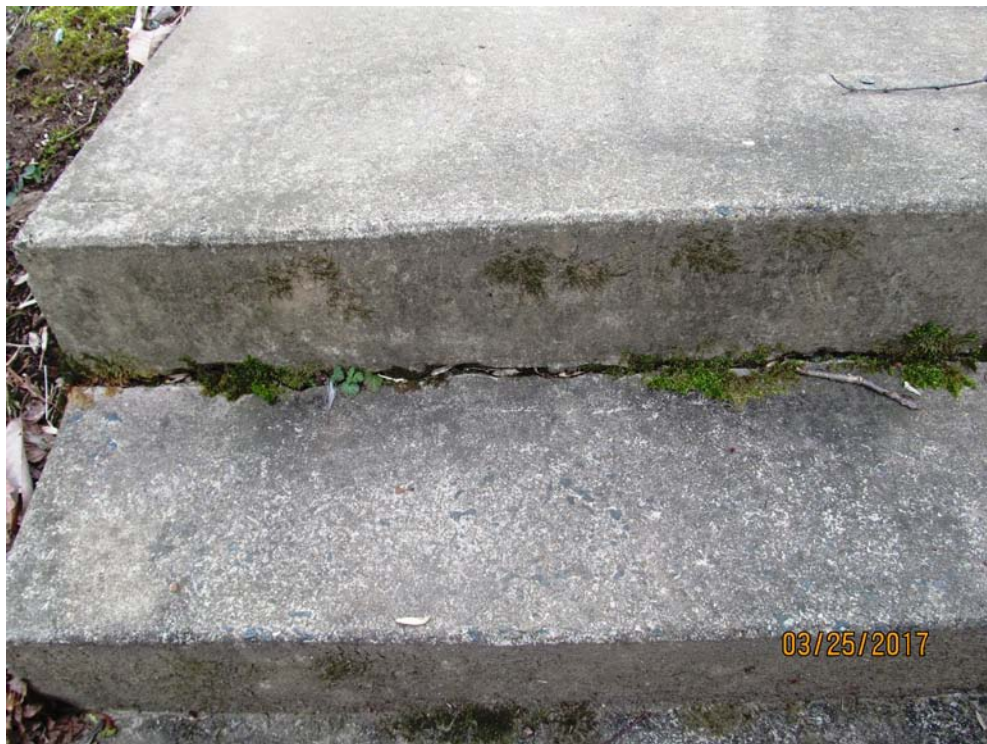
Concrete steps are located on a trail between Cricklewood Court and Trap Road. The steps were noted in fair condition for their age; with cracks and surface deteriorations noted at isolated locations. Several wood bridges feature concrete approaches, observed in overall fair condition for their age. In general, concrete pedestrian walkways can be expected to provide approximately 30 years of useful life. Pons & Associates recommends all concrete flatwork be replaced in Year 8 of the term.

Photograph No. 6: Step crack.

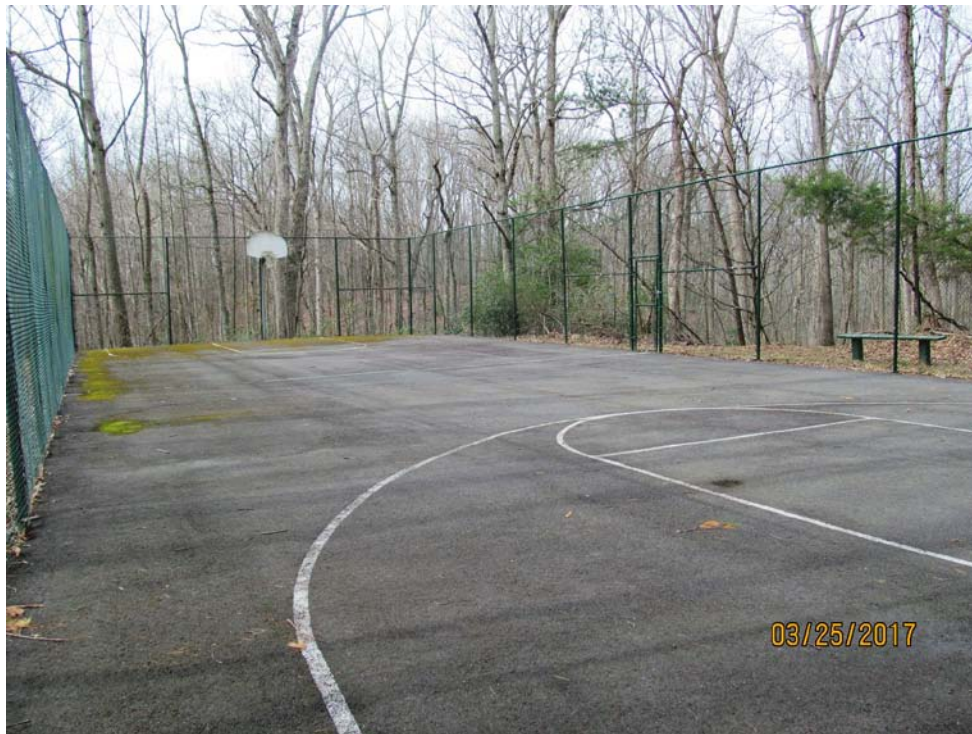
An asphalt-paved all-purpose court (lined and equipped for basketball) is accessed via a trail from Trapline Court. The asphalt surface was noted in fair condition; although heaving of the asphalt was noted at isolated edge locations. A significant amount of moss vegetation was noted on the surface at the south end of the court. Significant erosion at the asphalt edge and post bases was observed at the east side of the court. Pons & Associates recommends the court edge erosion be remediated within the next year as a part of the maintenance budget. The court striping and basketball equipment was noted in fair condition. The site contacts reported that the court surface was repaved in August 2011 (six years old). In general, basketball courts can be expected to provide approximately 15 years of useful life. Pons & Associates recommends the all-purpose court be resurfaced in Year 10 of the term.

Photograph No. 10: All-Purpose Court.

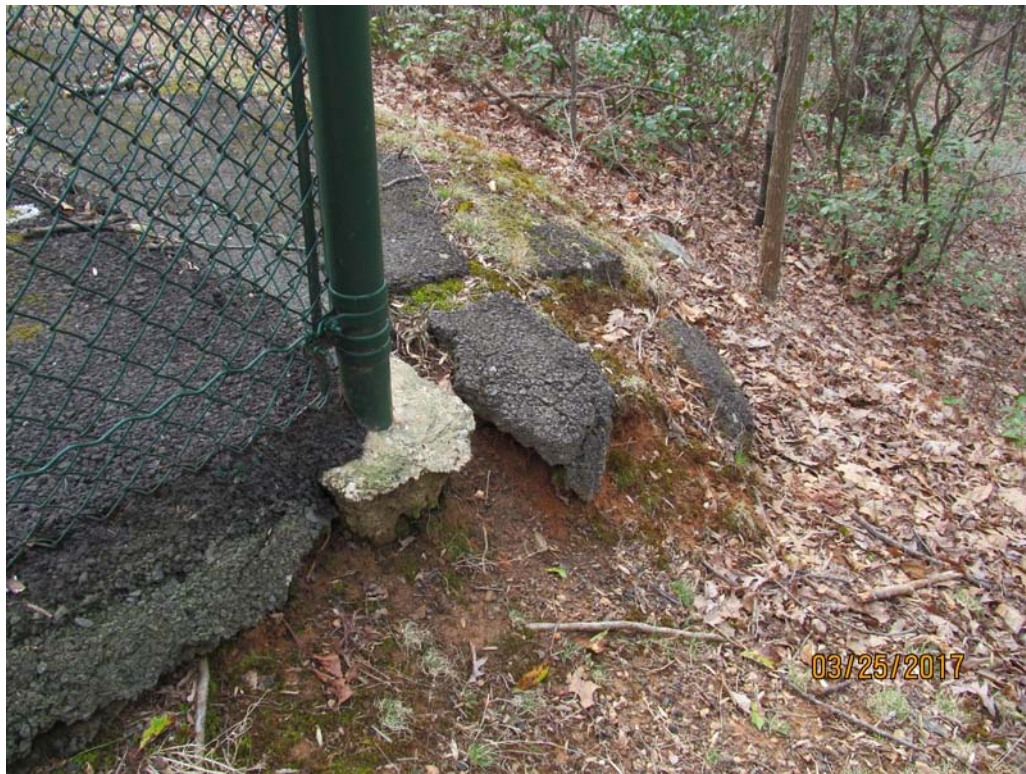
Photograph No. 13: Post footing erosion at All-Purpose Court.

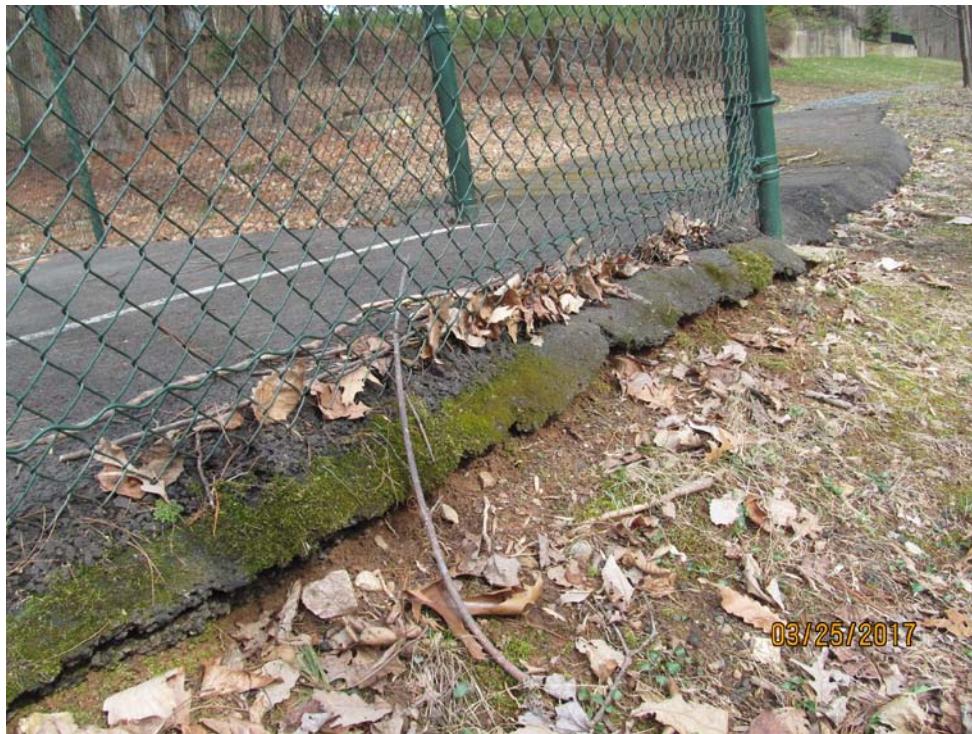
Photograph No. 14: Surface edge erosion at All-Purpose Court.

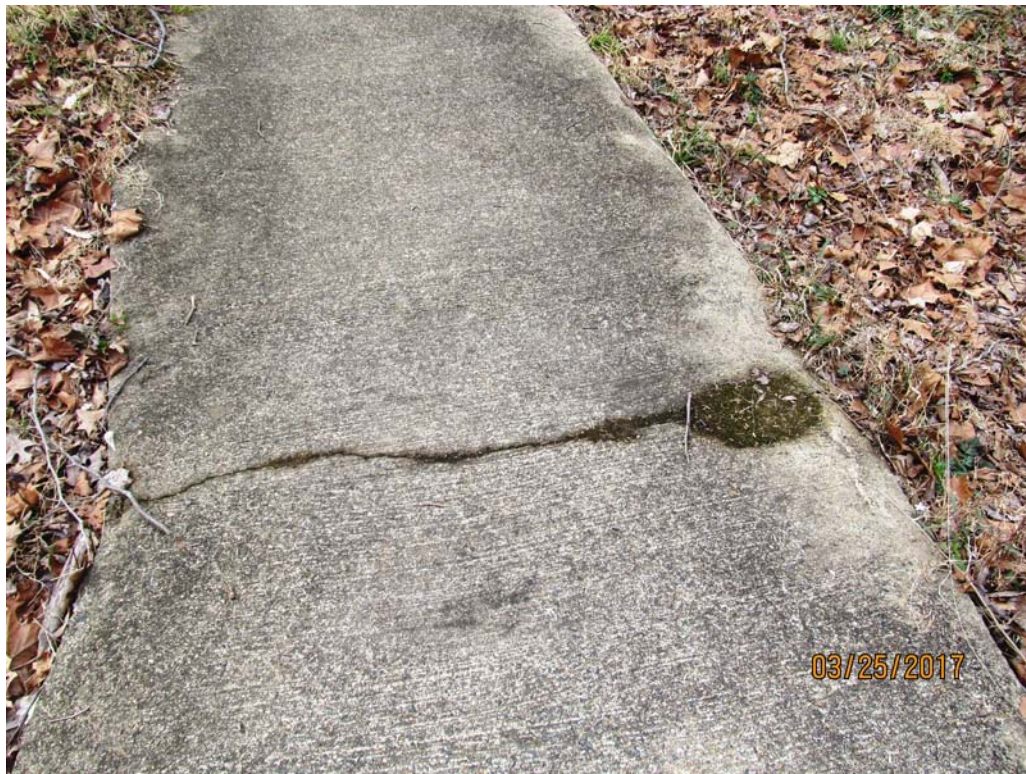
Photograph No. 19: Crack in concrete approach to Bridge #1.

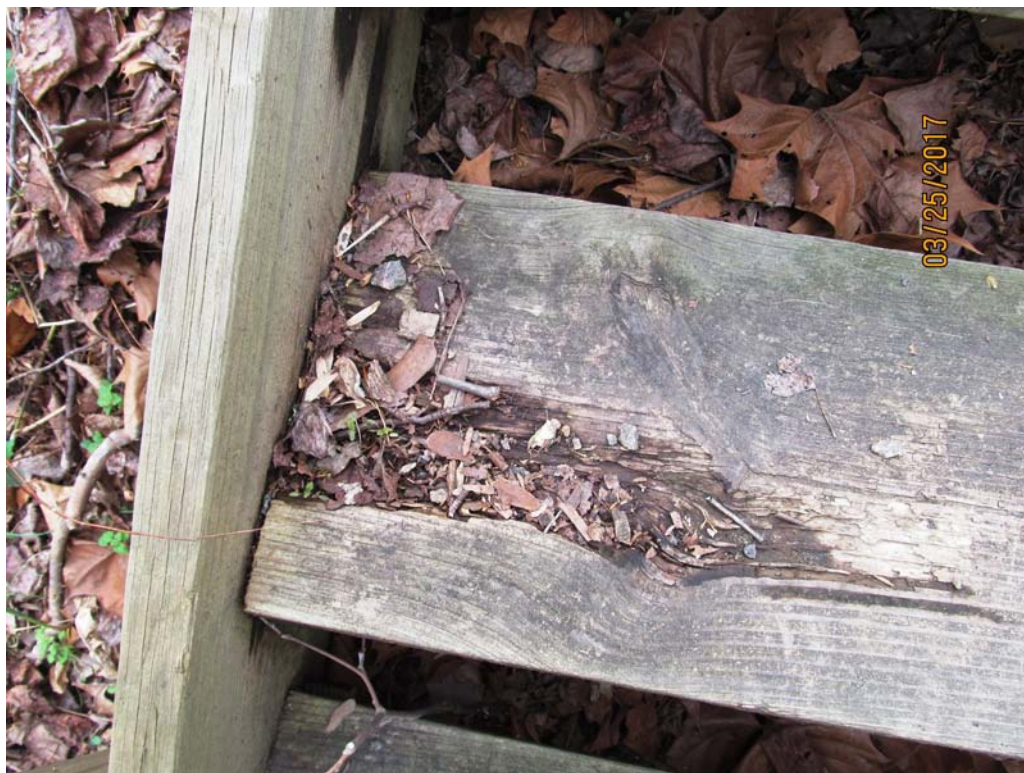
A set of wood steps is located proximate to a bridge (Bridge #1 on Figure 1) between Wolf Den and Wood Trap Woods subdivisions. The steps were noted to be aged and deteriorating at several locations. The site contacts reported the steps are approximately 15 years old. Pons & Associates recommends that the wood steps be replaced in Year 3 of the term. Steps consisting of wood sleepers and asphalt landings access the tennis courts proximate to Laurel Hill Road. The sleepers and asphalt were noted aged. Pons & Associates recommends the access steps to the tennis courts be replaced in Year 4 of the Term. Steps consisting of wood sleepers and gravel-surfaced landings were noted at the end of the trail to Glenridge Court. The wood sleepers were noted in fair condition, and can be expected to last through the Term with individual replacements on an as-needed basis as a part of maintenance.

Photograph No. 21: Deterioration at wood steps.

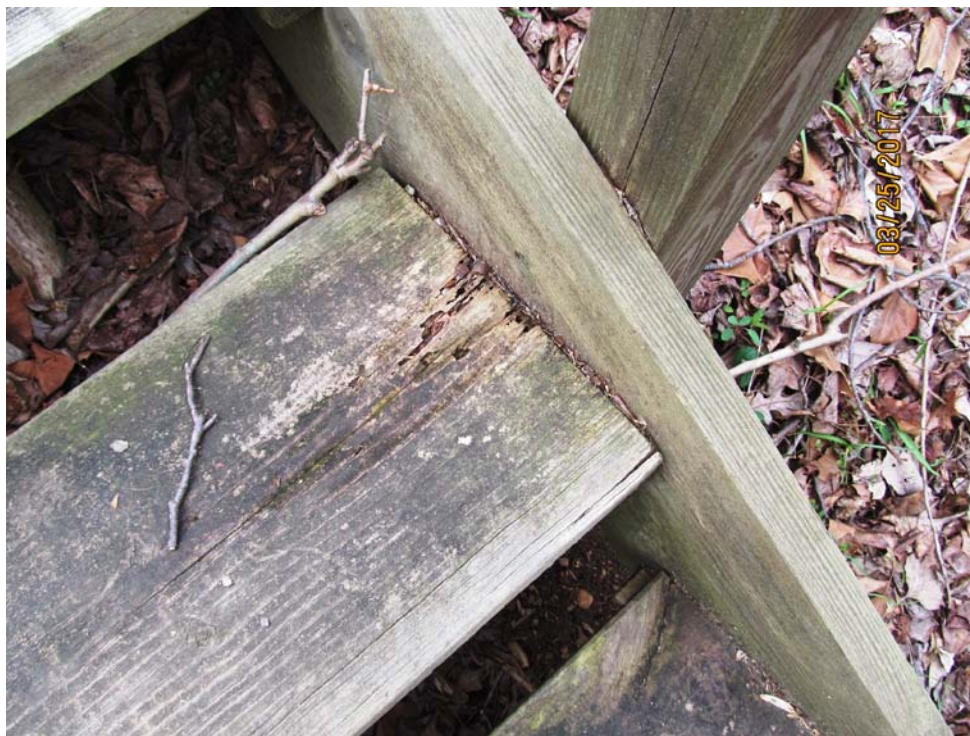
Photograph No. 22: Deterioration at wood steps.

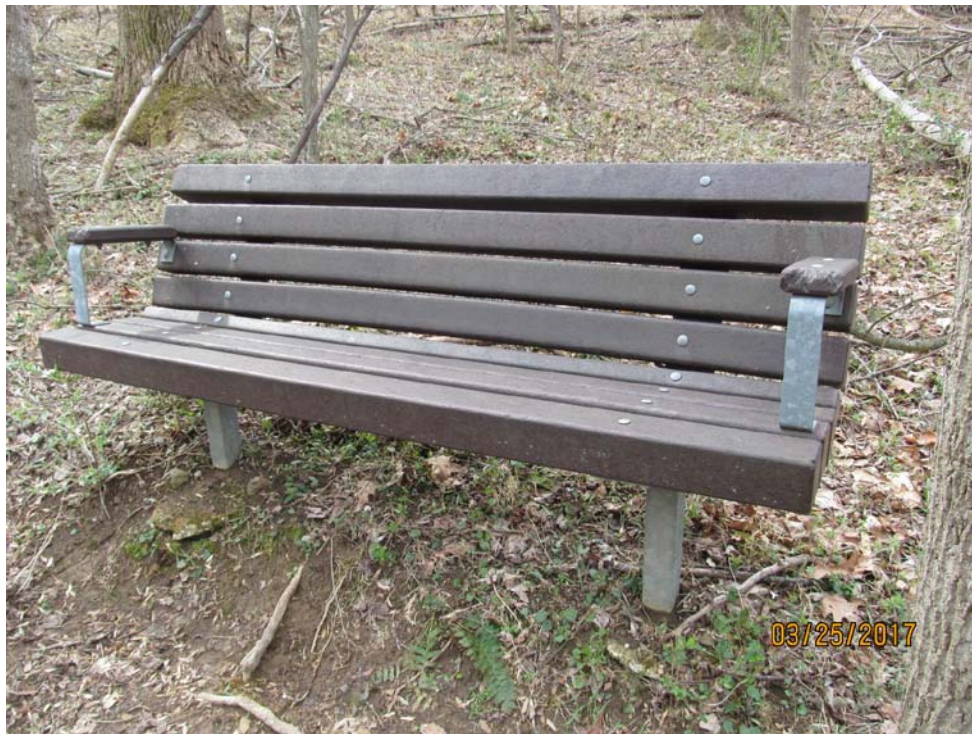
A total of eight resin/metal benches are located along the trail system and at the all-purpose court; reported to have been installed in November 1998 (17 years old). These benches were noted in fair condition for their age. Two benches are located at the tennis courts, approximately five years old, and were noted to be in good to fair condition. In general, site furniture can be expected to provide approximately 20 years of useful life. Pons & Associates recommends the benches be replaced in Year 5 of the Term.

Photograph No. 24: Typical resin/metal bench.

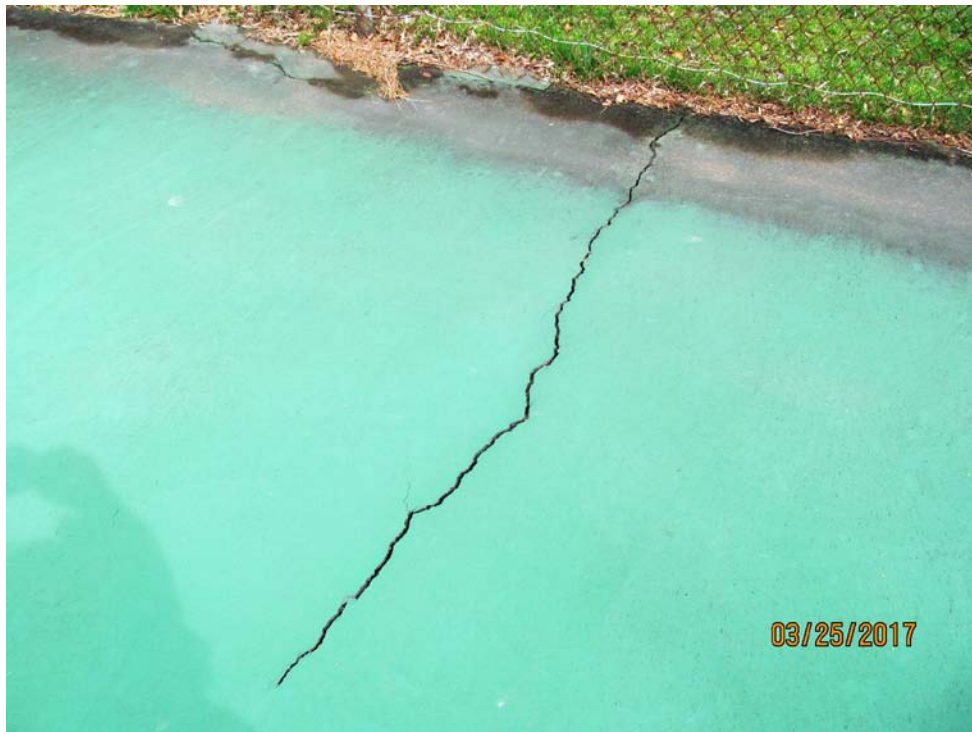
Two tennis courts (including a narrow recreation open court) on painted concrete pavement are located proximate to Laurel Hill Road. The concrete deck was observed to be in fair condition, with isolated cracks noted. The site contacts reported that approximately five years ago, the tennis courts were reconfigured from three to two courts; with painting and striping performed. The tennis net equipment was observed in good to fair condition. In general, tennis courts can be expected to provide

Photograph No. 32: Crack in tennis court deck.

approximately 15 years of useful life. Pons & Associates recommends the tennis courts be resurfaced in Year 10 of the term. Striping and replacement of equipment are considered a part of maintenance.

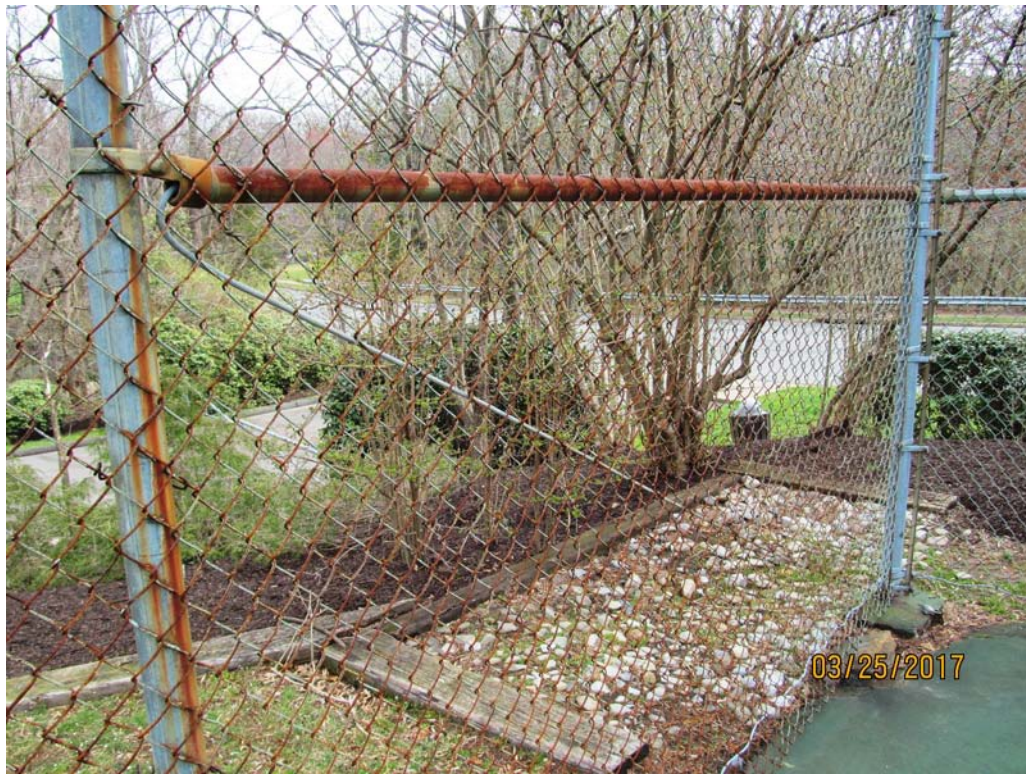
Photograph No. 33: Typical fence deterioration (corrosion) at tennis courts.

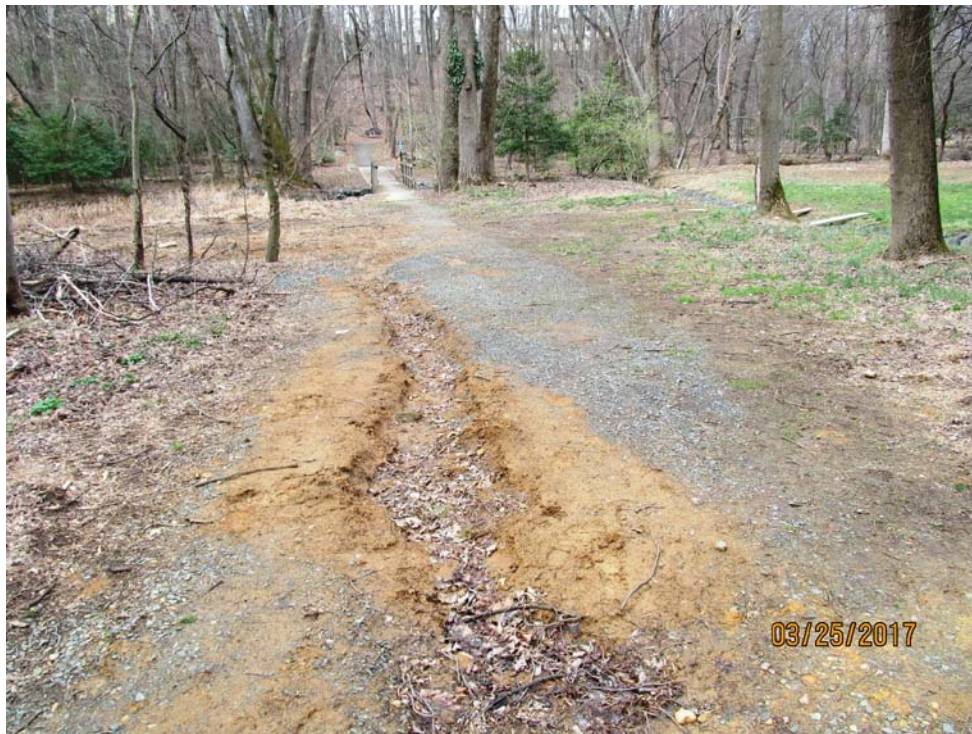
Photograph No. 44: Deteriorated trail at east end of Bridge #3.
